## Airworthiness Directive

Amendment 39-4930; AD 72-03-03 R3

Airworthiness Directives; CESSNA Models 150F, G, H, J, K, L, F150F, G, H, J, K, L, A150K, L, FA150K, L, 172F, G, H, I, K, L, F172F, G, H, K, R172E, F, G, H, FR172E, F, G, H, 177, 177A, B, 177RG, F177RG, 182E, F, G, H, J, K, L, M, N, A182J, K, L, M, N, 205, 205A, 206, P206, P206A, B, C, D, E, and , TP206A, B, C, D, E, U206, U206A, B, C, D, E, and , TU206A, B, C, D, E, 207 and T207, 210D, E, F, G, H, J, K, T210F, G, H, J Airplanes

Docket No. 86-CE-71-AD; Amendment 39-6669; AD 87-20-03 R2

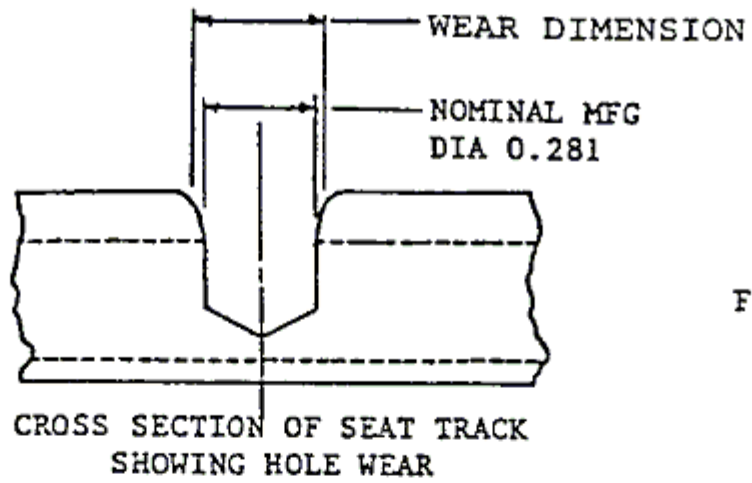
FIGURE 1

(1) Measure each hole in the seat track(s) for excessive wear. When checking these holes for wear, an allowance of 0.020 inches below the edge of the normal surface is permitted for the required measurement.

(i) If the wear dimension across any hole exceeds 0.36 inches but does not exceed 0.42 inches (see Figure 1), continue to measure each hole every 100 hours TIS for excessive wear.

(ii) If the wear dimension across any hole exceeds 0.42 inches, prior to further flight, replace the seat track.

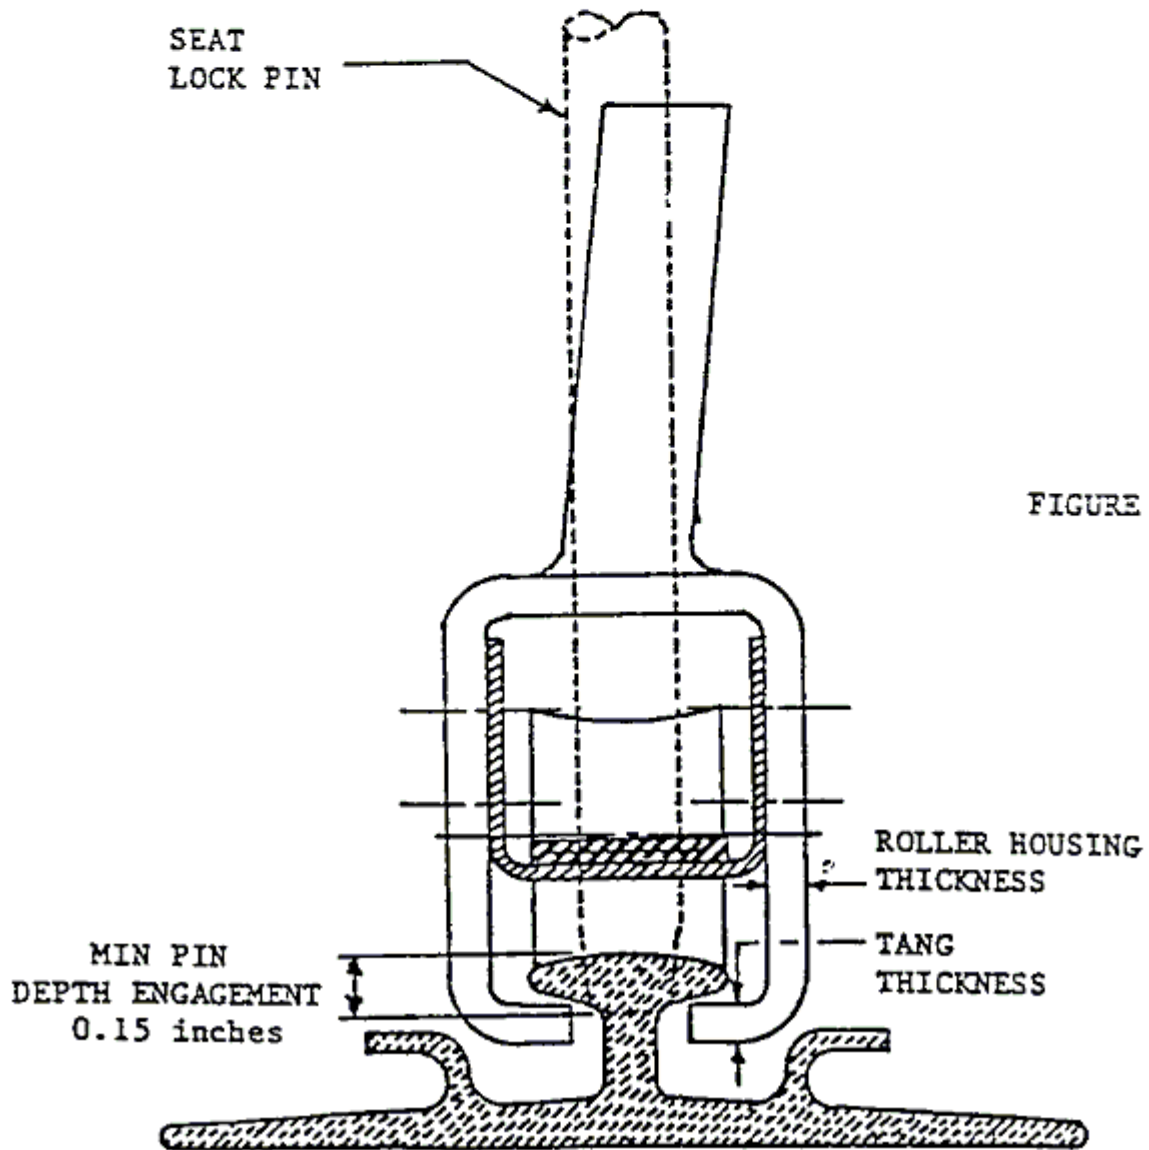
FIGURE 2

(3) Lift up on the forward edge of each seat to eliminate all vertical play. In this position, measure the depth of engagement of each seat pin. If the engagement of any pin is less than 0.15 inches (see Figure 2), prior to further flight, replace or repair necessary components to achieve a seat pin engagement of 0.15 inches or greater. If the track is worn, this dimension is measured from the worn surface, not the manufactured surface.

(5) Measure the wall thicknesses of the roller housing and the tang (see Figure 2). If the tang thickness has worn to less than 1/2 the housing thickness, prior to further flight, replace the roller housing.

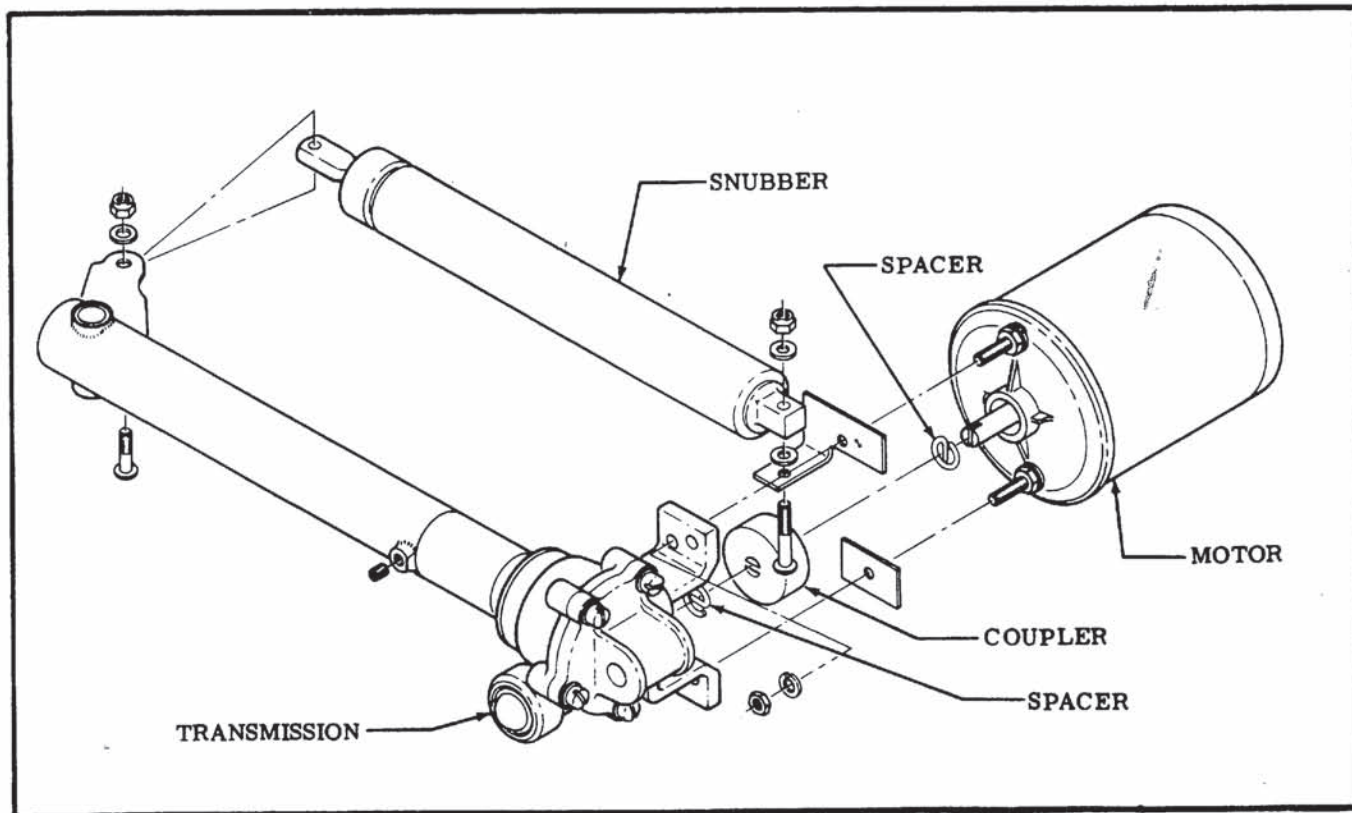
Figure 1. Spacer Installation.

1. Spring-type spacers have been added to Service Kit SK150-37. These spacers are installed as shown in Figure 1 below and serve to locate the flap motor to actuator coupling centrally insuring proper engagement of the motor shaft and actuator shaft.
